Michael L. Bench
Consulting Arborist
(831) 594-5151

**An Evaluation of A Coast Live Oak Tree
Menlo Park City School District
275 Elliot Drive
Menlo Park, California**

275 Elliot Drive
Menlo Park, CA

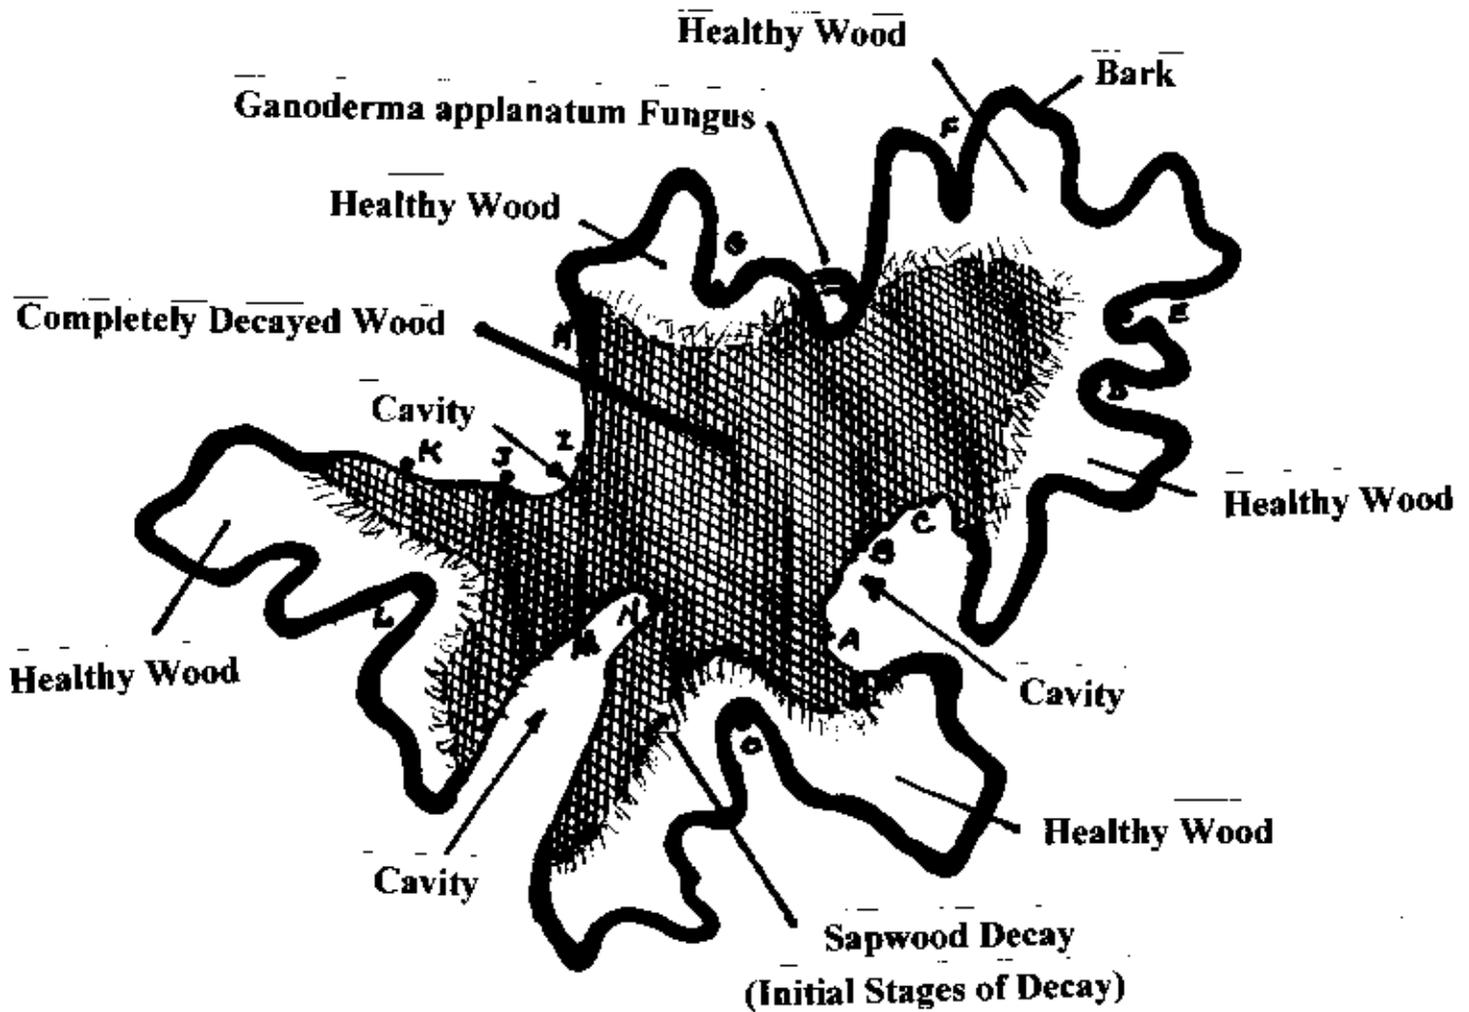
Sketch: Interior Wood Decay

I use the data collected by this method to make a Drawing (to Approximate Scale). It is not possible to make a drawing of exact scale, unless numerous lazer measurements are taken. This drawing is attached.

A high percentage of the interior structural wood of the tree is completely destroyed by the two decay pathogens. The tree remains standing due to the healthy structural wood in the buttress roots, which are air well distributed around the trunk on all sides.

There is no way to estimate how long this tree may remain standing. However, the current decayed wood is extensive, and the active *Ganoderma applanatum* disease is quite aggressive. I do not expect this tree to remain standing for very long, despite its dense beautiful canopy.

It is very unfortunate, but in my opinion, the evidence is overwhelming, such that I have no alternative but to recommend the removal of this oak tree. Because of the safety concerns, I recommend that the removal be done as soon as possible.
